### Hydrilla in Ohio

Alum Lake

## 2022 Management

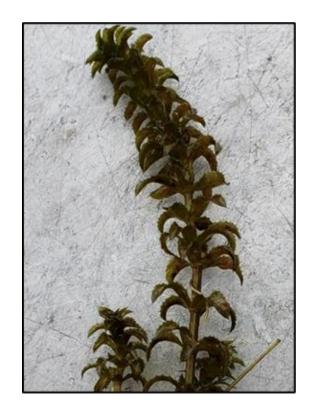
Serrated leaf edges

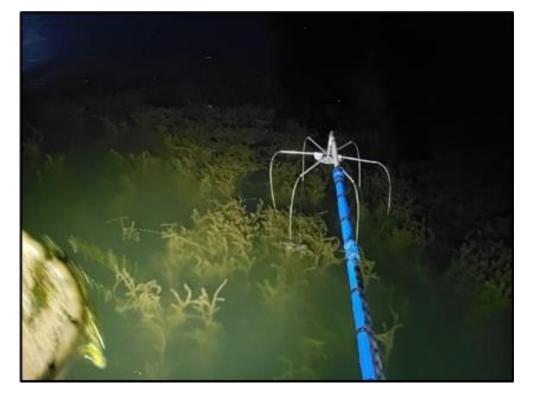
Hydrilla in the water column during sampling

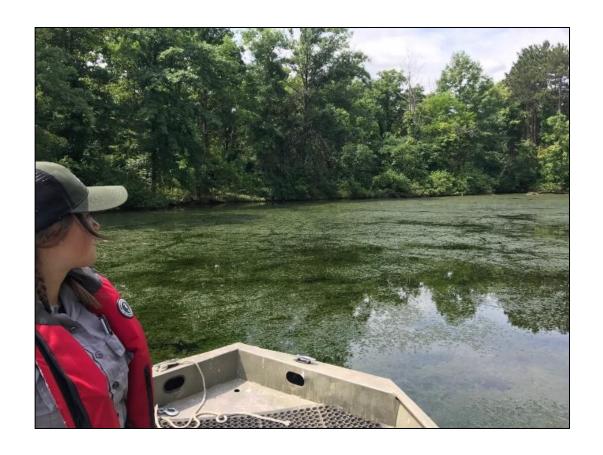
USACE Huntington Ranger inspects a hydrillainfested bay

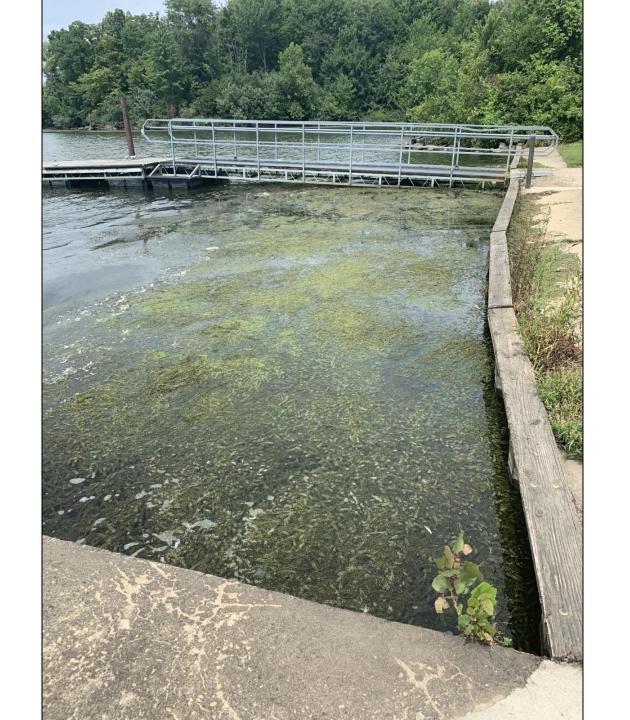
Sparse 1-10%

Moderate 10-25%

Dense 25-100%

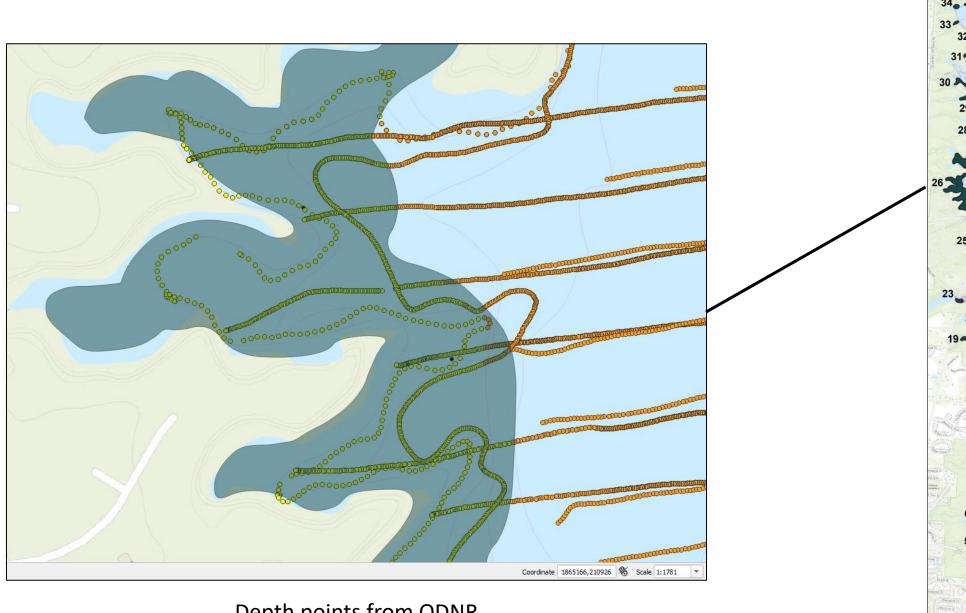
Depth points from ODNR
