Indian Lake

Lake Vegetation Assessment and Plan

Report Prepared By:

**AQUA DOC Lake & Pond
Management Inc.**

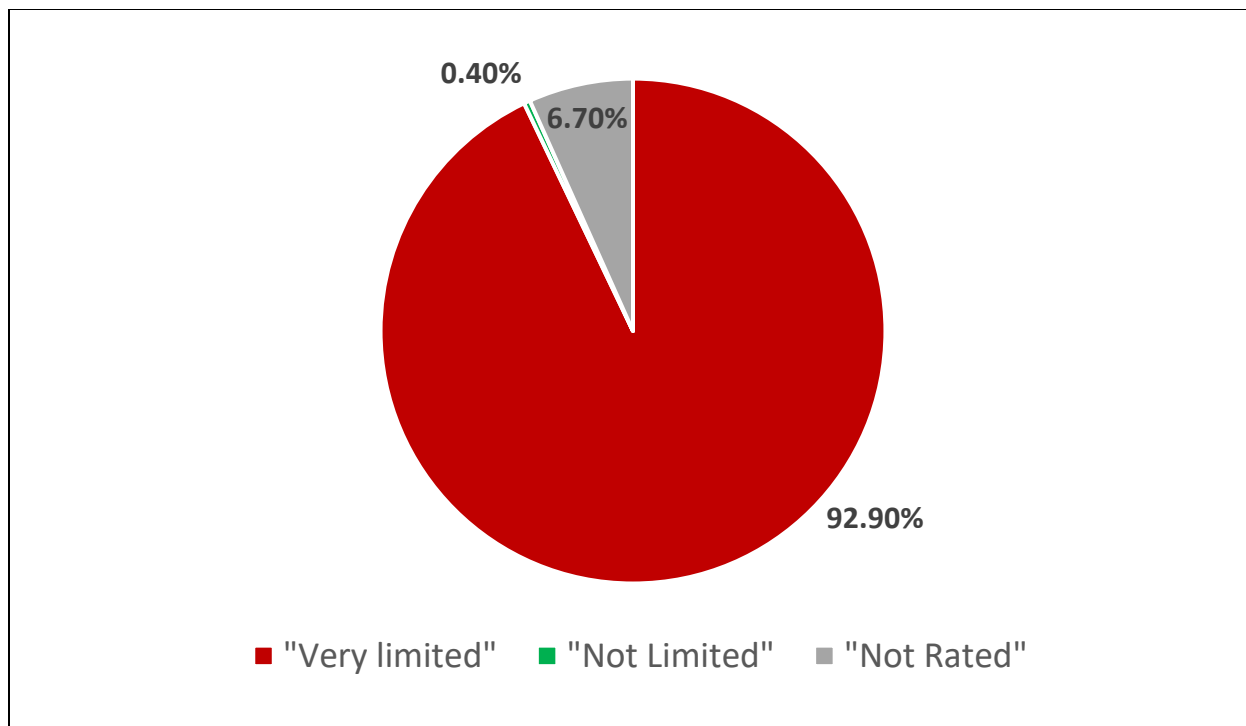
Figure 7: Soil suitability for septic systems in the Indian Lake watershed (USDA 2022).

Soils within the extent of the Indian Lake watershed are poorly suited for septic system use: 92.9% is considered “very limited” for proper functioning and 0.4% is considered “not limited” and suitable for use (Figures 6 and 7).

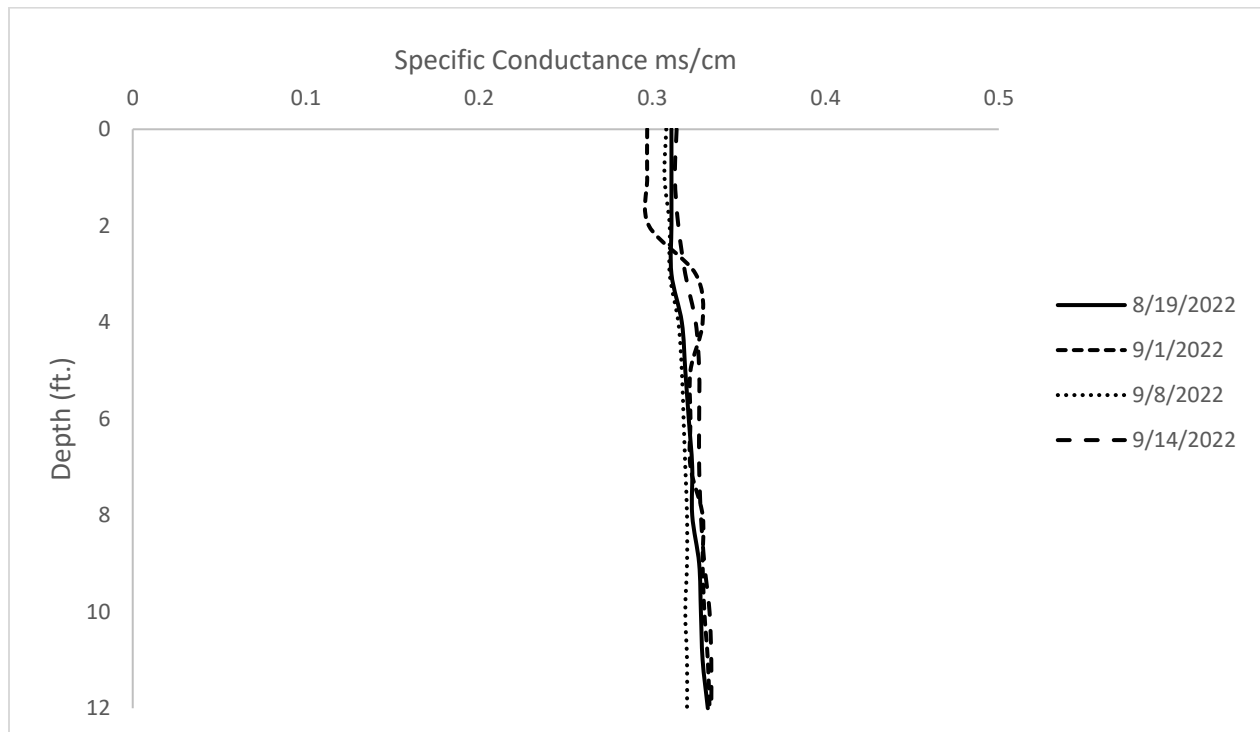
Specific conductivity – Specific conductivity remained relatively consistent throughout the four sampling dates. The highest observed value was found to be 0.334 ms/cm at the bottom of the sampling location on 9/14/2022. The lowest was found to be 0.297 at the surface of the sampling point on 9/1/2022. Specific conductance trends within the water column are shown in Figure 11.

Figure 11: Specific conductance depth profiles of Indian Lake from 8/19/2022 to 9/14/2022.

Specific conductance did not showcase any values within the observed depth profiles that would suggest Indian Lake is impacted by excessive ions in its water during the time of sampling (e.g. road salts from the winter season; Figure 11). For many reservoirs, excess ions

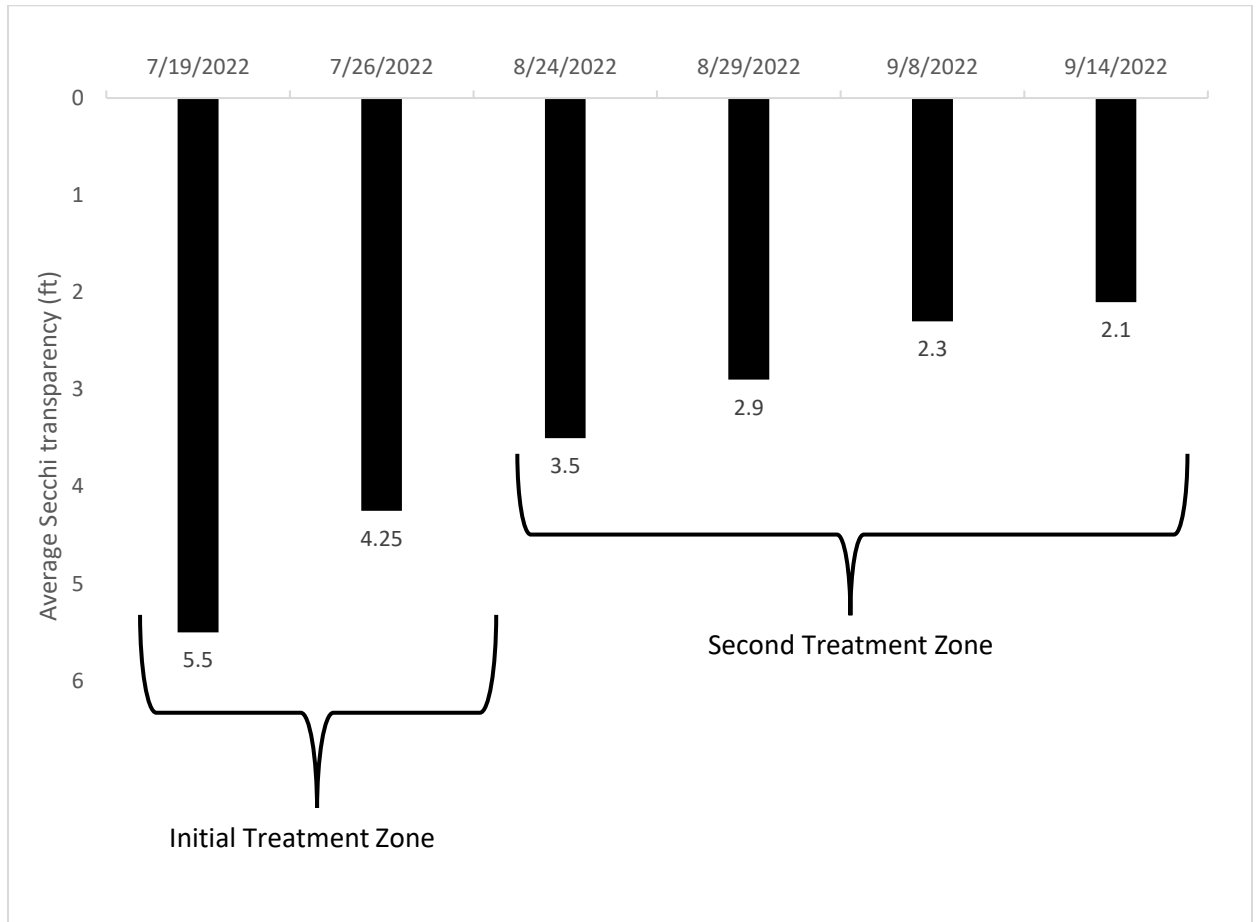
Figure 19: Average Secchi transparency from July 19 to the final sampling date on September 14 in the ProcellaCOR® treatment test zones.

Average Secchi depth (transparency) shallowed from the initial data collection date where observed values reached an average depth of 5.5 ft within the initial July test zone to 2.1 ft within the second application zone (Figure 19). These shallowing values corresponded with higher variability in chlorophyll *a* concentrations within the second application test zone as well as a noted increase in turbidity (Figures 20 and 21). These observations together could indicate an increase in algal growth potential as vegetation was being managed. As more submerged vegetation growth is eliminated from the reservoir, a greater net quantity of available P becomes usable to algal growth which can allow for chlorophyll *a* levels to fluctuate under additional adequate environmental conditions (e.g. when more sunlight is available and little wind action). It could also be surmised that the noted decrease in SD as well as the increase in turbidity could be the result of resuspension of bottom sediment material due to wind action once vegetation had been managed. Although possible, DO levels would also be consistent from surface to bottom during complete water column mixing which was never observed during our sampling. Turbidity quantification does not distinguish from sediment derived

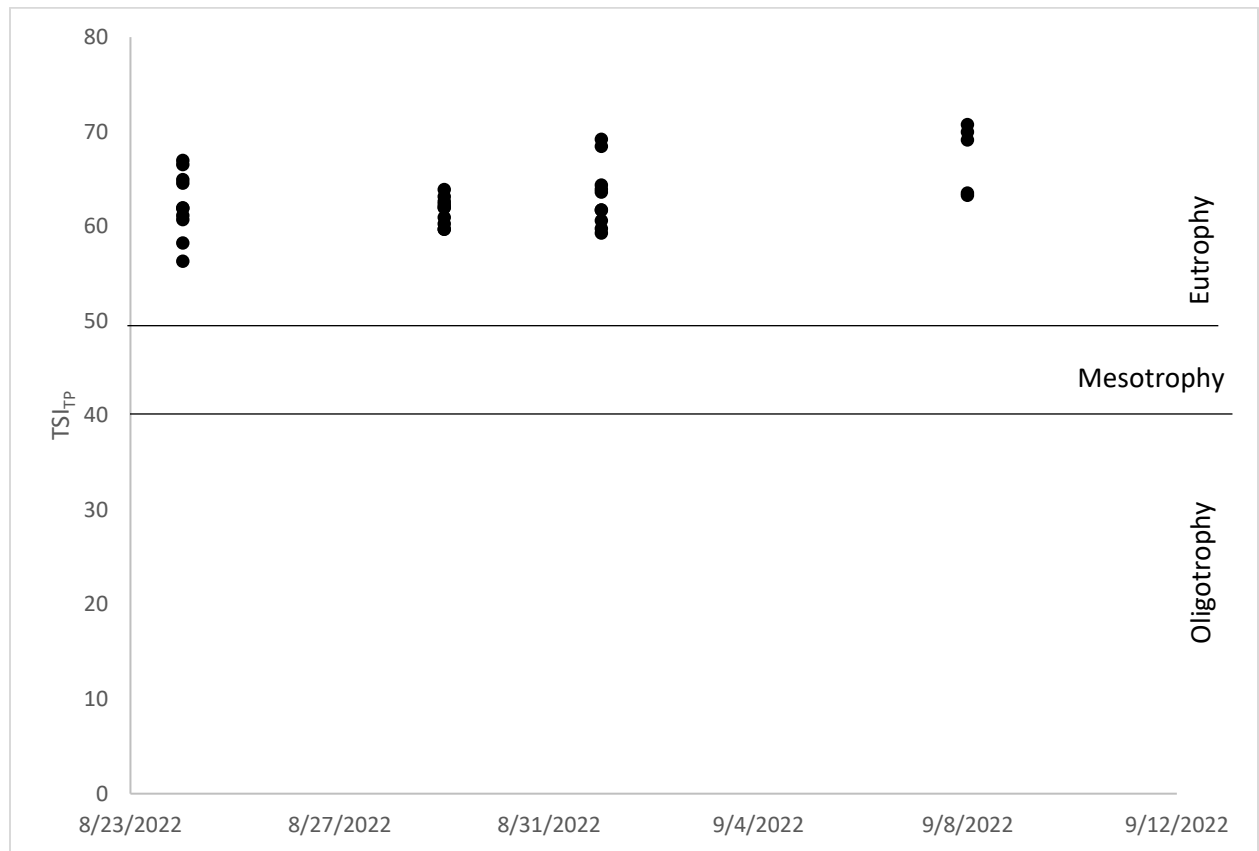
Figure 23: Carlson's TSI_{TP} values for Indian Lake from nutrient data collected in the second ProcellaCOR® test zone (8/24/2022 – 9/8/2022). Different estimated trophic designations are identified on the right of the graph.

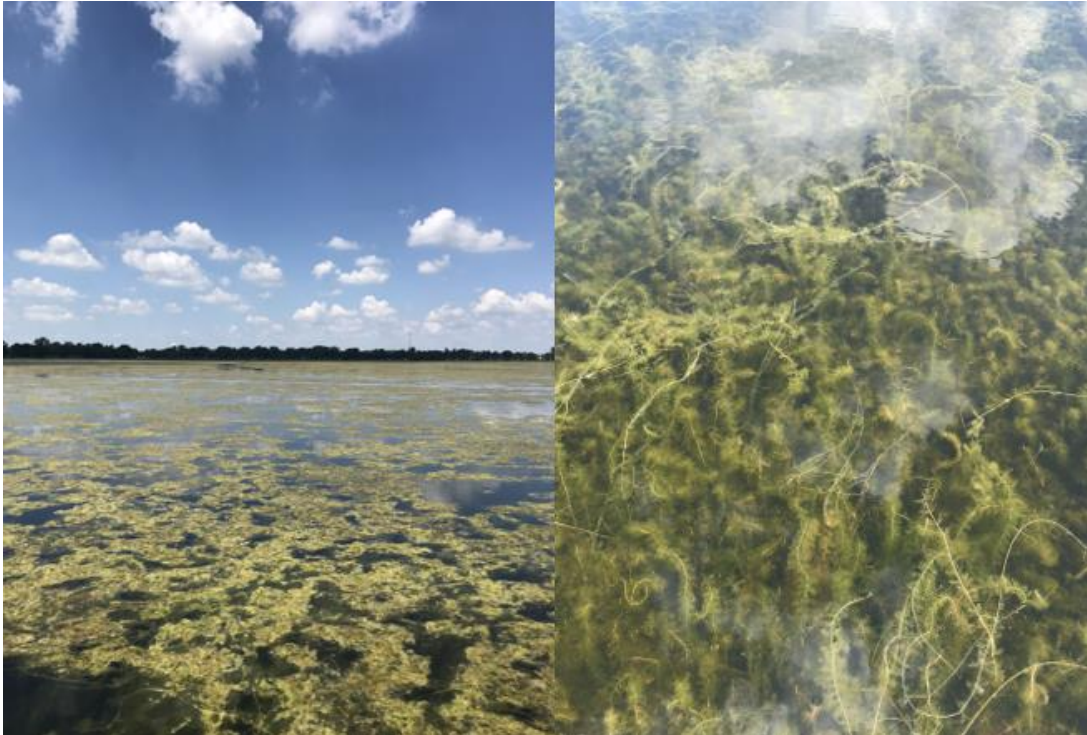
Figure 26a and 26b: Images of the extent of the submerged vegetation growth within the initial July treatment test zone. Photos taken on 7/19/2022 (Photos: Edward Kwietniewski).

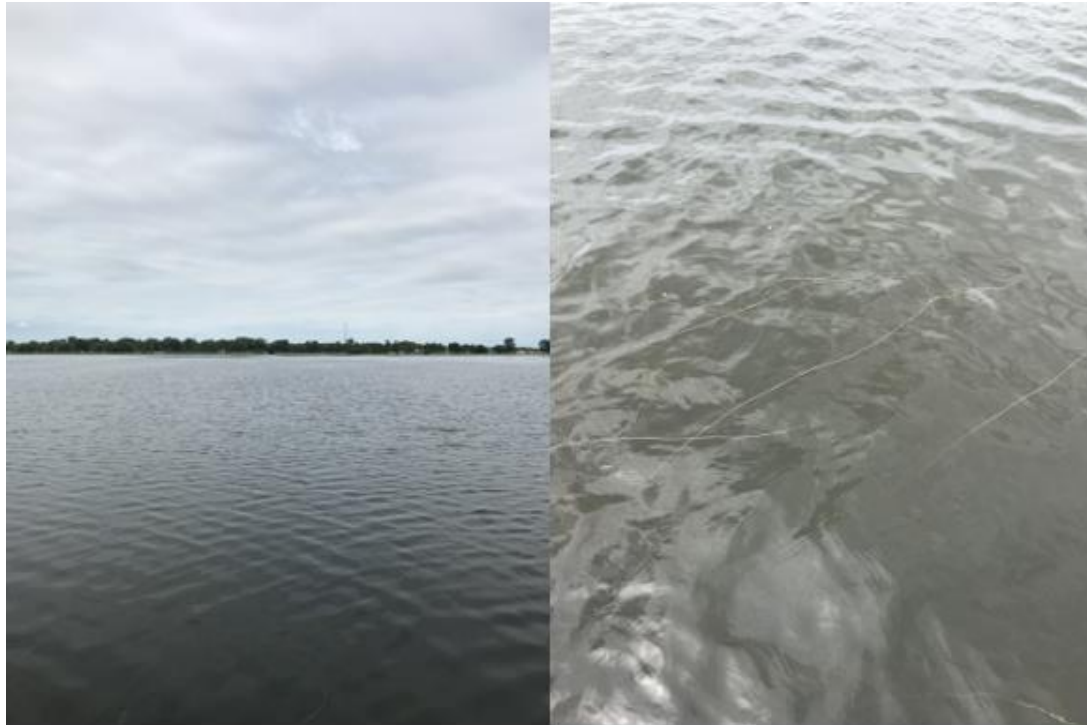
Figure 27a and 27b: Images of the initial July treatment zone 2 weeks post application. Photos taken on 7/26/2022 (Photos: Edward Kwietniewski).

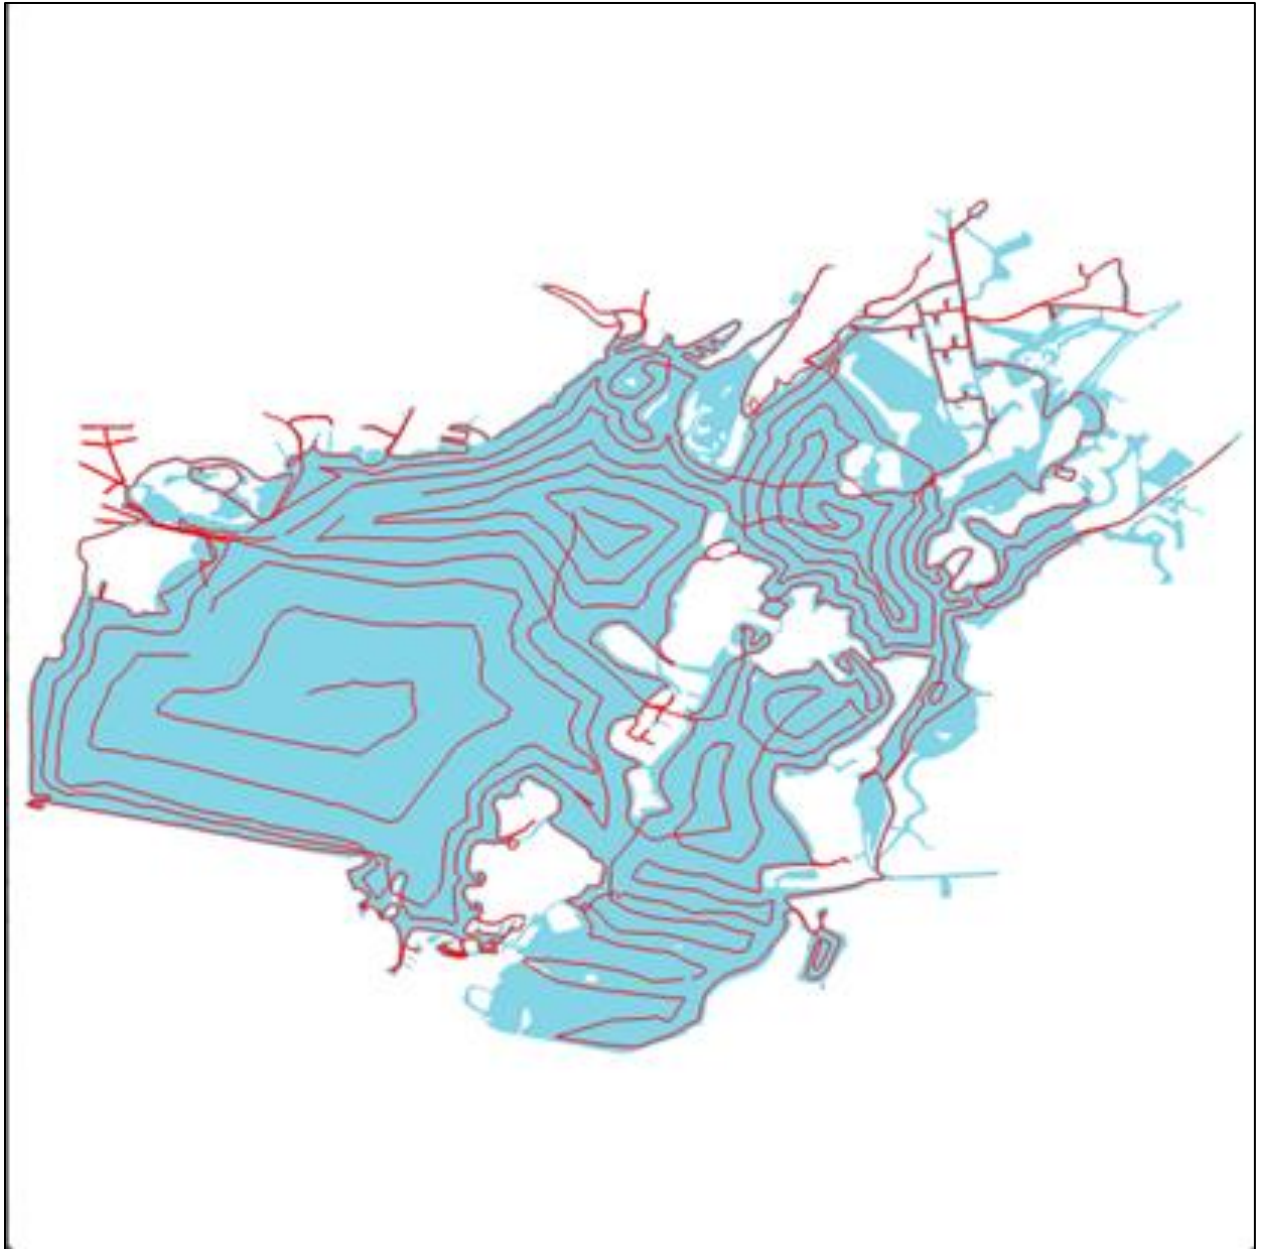
Figure 33: Map of the track used to sonar map macrophyte density utilizing Biobase®. Red lines indicate the boat track.

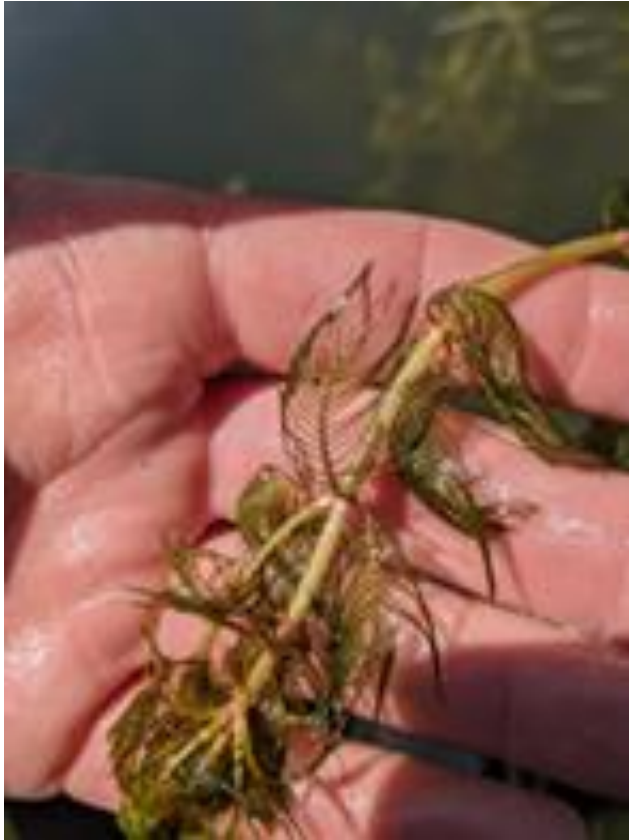
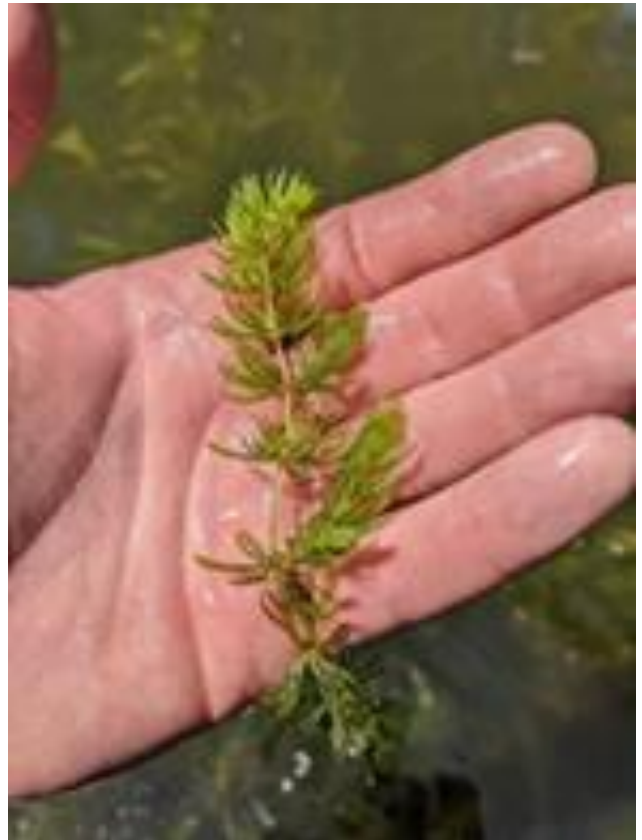
Figures 41a and 41b: Images of EWM (left) and coontail (right) from Indian Lake. (Photos: Edward Kwietniewski)

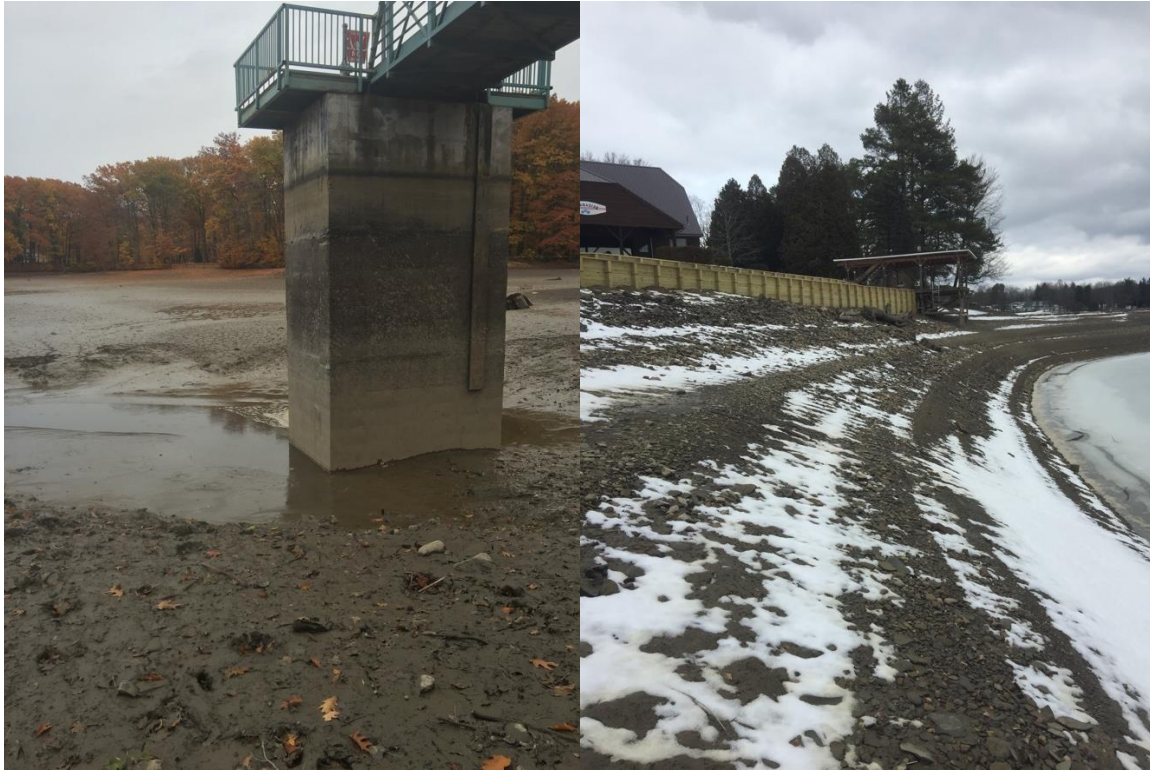
Figures 44a and 44b: Image of a winter whole lake drawdown of Green Lake in Orchard Park, NY (left) and partial drawdown of Rushford Lake in Canadea, NY (right). Exposed benthic sediment and materials are showcased in both images. (Photos: Edward Kwietniewski)

flourish, Figures 44a and 44b). The draining, exposure to ambient air, and desiccation eliminates vegetation growth, typically for an extended period of time under optimal conditions (freezing, high heat; 1 – 2 months Cooke 1980). Although drawdown is a commonly successful vegetation management technique, it is selective to submersed plants whose reproductive structures and strategies are able to survive desiccation (Table 11; Carmignani and Roy 2021, Holdren et al. 2001). Therefore, the use of this technique should be limited to those plants that are susceptible and there should be awareness that an increase in non-susceptible vegetation is likely to occur following die-offs of target species. Since drawdown requires the ability to release water, it is typically a technique that is reserved for reservoirs with the capacity to do so. Many natural lakes (e.g. kettle lakes, plunge pool, etc.) are unable to utilize this technique because of this. Costs associated with water drawdown are typically negligible if the reservoir already has the capacity to perform the technique.

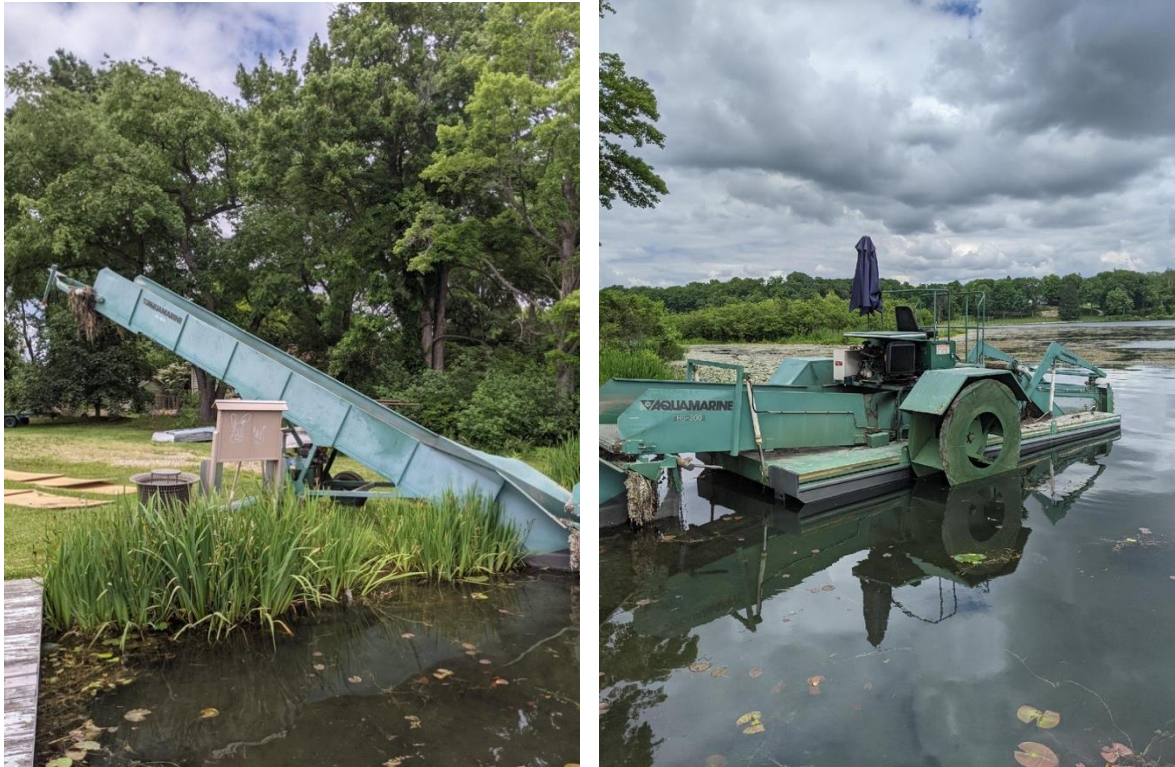
Figures 45a and 45b: A smaller sized mechanical harvester (right) and its drop off conveyor (left) used to load dump trucks for disposal (Photos: Edward KwieTKNiewski).

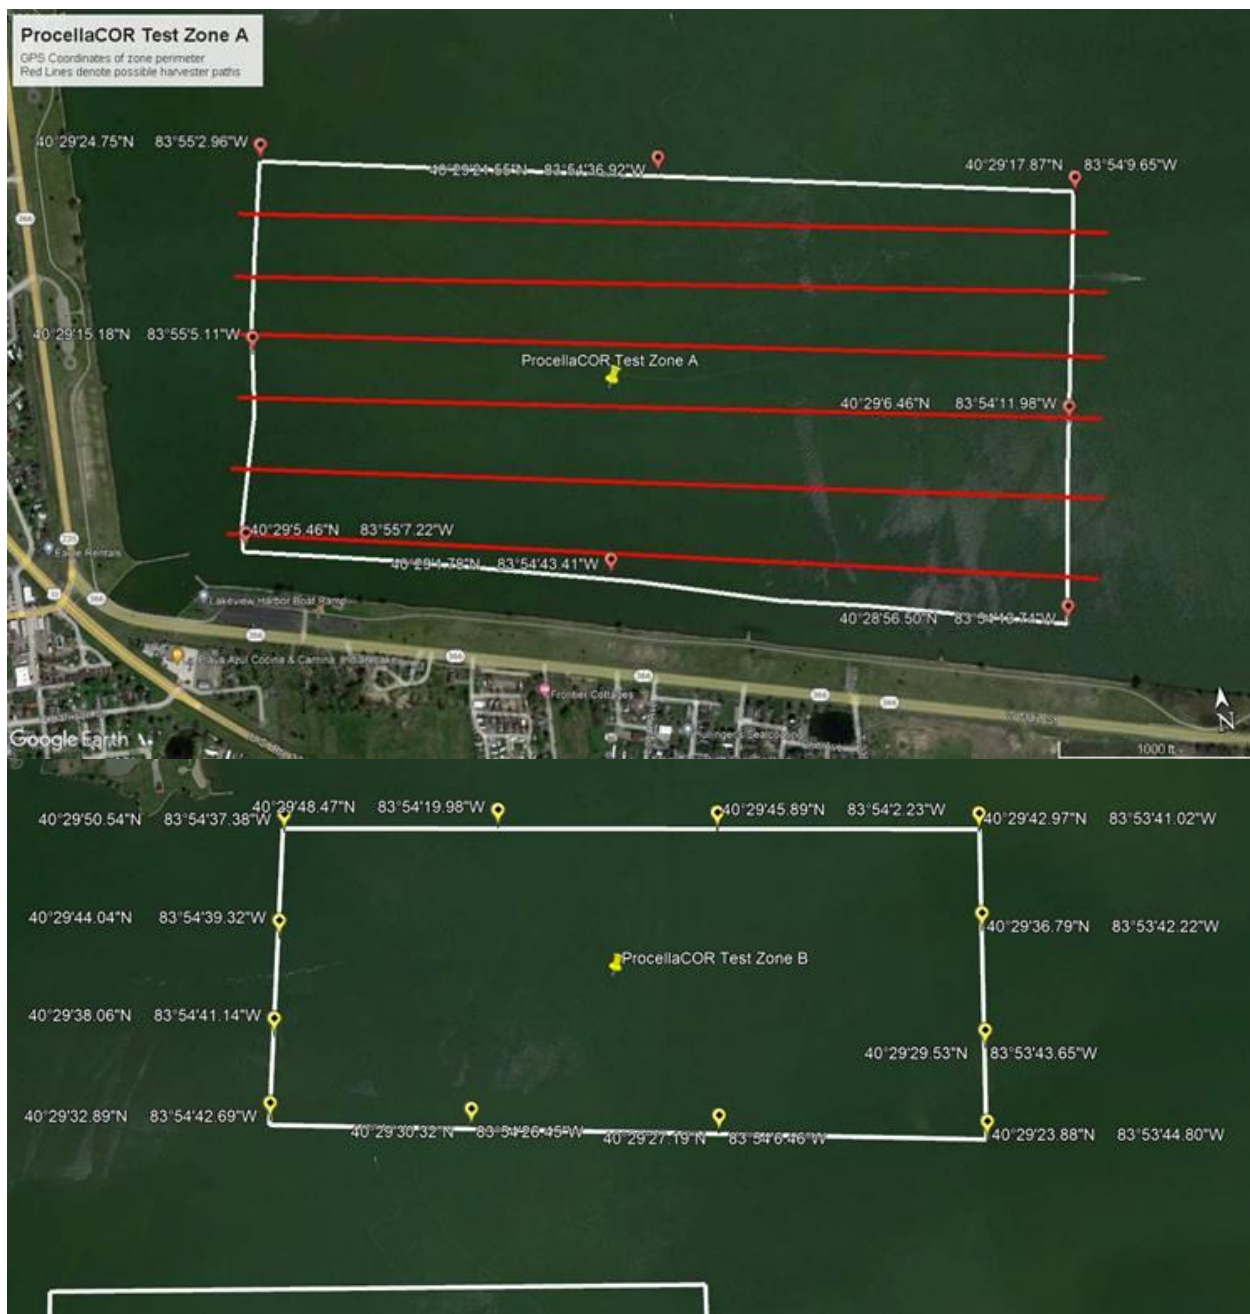
Figures 47a and 47b: Adjusted images to denote the two ProcellaCOR® application test zones (top is initial application, bottom is second application). Perimeter latitude and longitude coordinates are included in the photos. Red lines in the initial application denote suggested channels for harvesting.

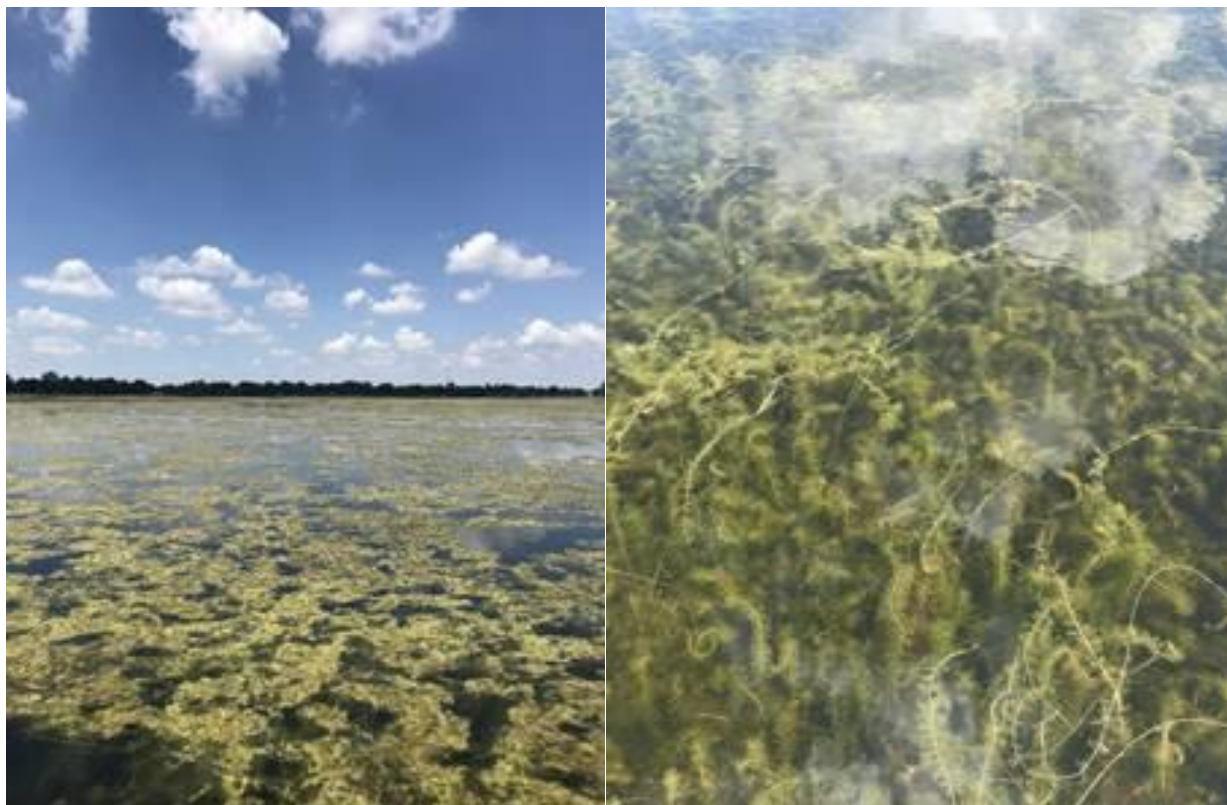
Figure 48a and 48b: Images of the extent of EWM and filamentous algae growth within the initial ProcellaCOR® application zone. Pictures were taken on July 19, 2022. (Photos: Edward Kwietniewski).

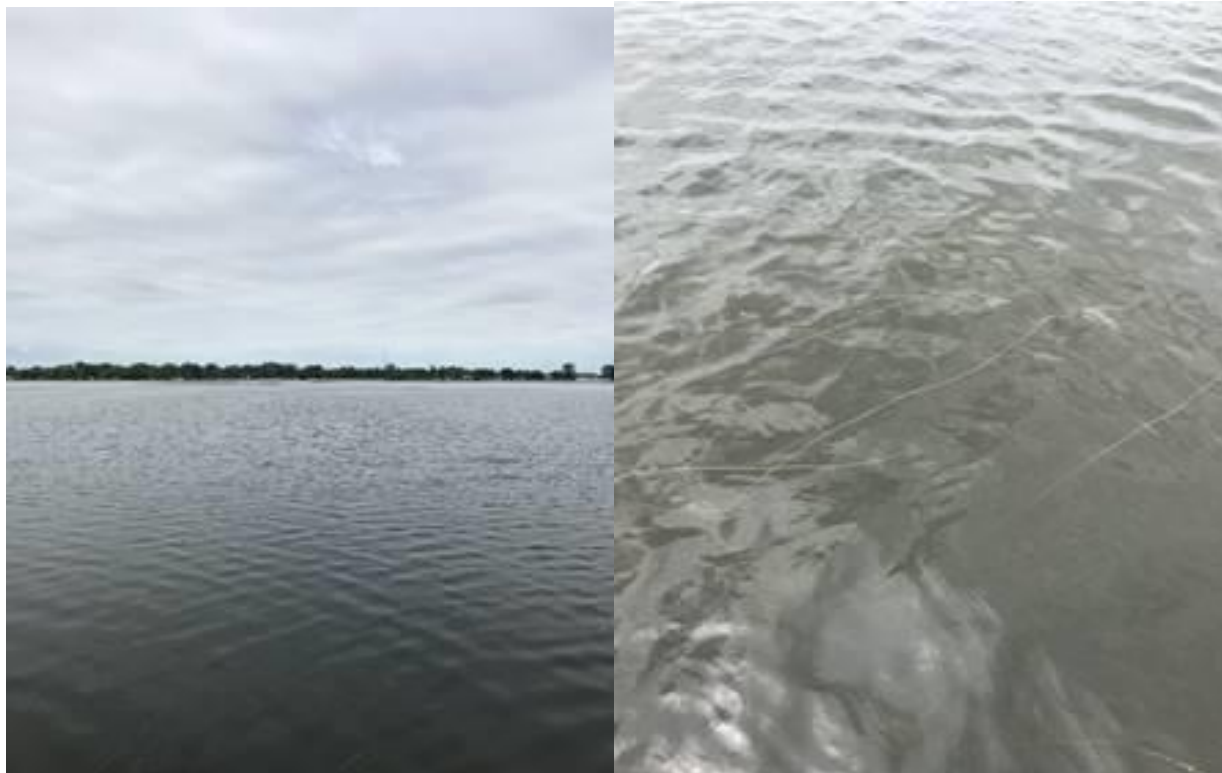
Figure 49a and 49b: Images of the initial ProcellaCOR® application zone on July 26, 2022. The left and right images are in the same locations as the left and right photos in Figures 48a and 48b. (Photos: Edward Kwietniewski)

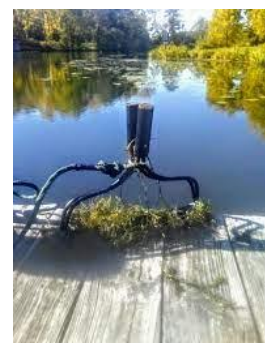
Aquatic plant sampling with a “macrophyte rake”

Depth and sediment depth with a sediment probe
